MICHIGAN DEPARTMENT OF TRANSPORTATION

STR 4532

BRIDGE SAFETY INSPECTION REPORT

Facility MILL STREET	Latitude / Longitude 42.11 / -84.2457	MDOT Structure ID 384093200038B01	Structure Condition Fair Condition(5)

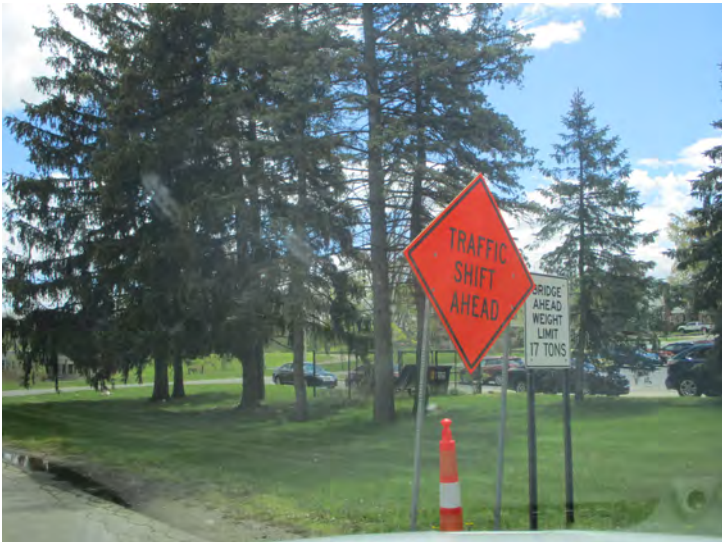
Weight limit signs in place on both ends of bridge	YES
Weight limit shown on signs at bridge	17_N_N
Required advance warning weight limit signs in place	NO

Document Name: 2.JPG
 Category: Posting
 Span Number:
 Comments: Advanced, west

Recommendation Type	Priority	Description
Deck Patching	H	Seal cracks HMA surface. Continue to monitor seal at shoulder/bridge rail interface for leakage into fill.
Super Repair	H	Repair spalls in soffit/walls.
Other	H	Install advance posting sign to the east of the structure.

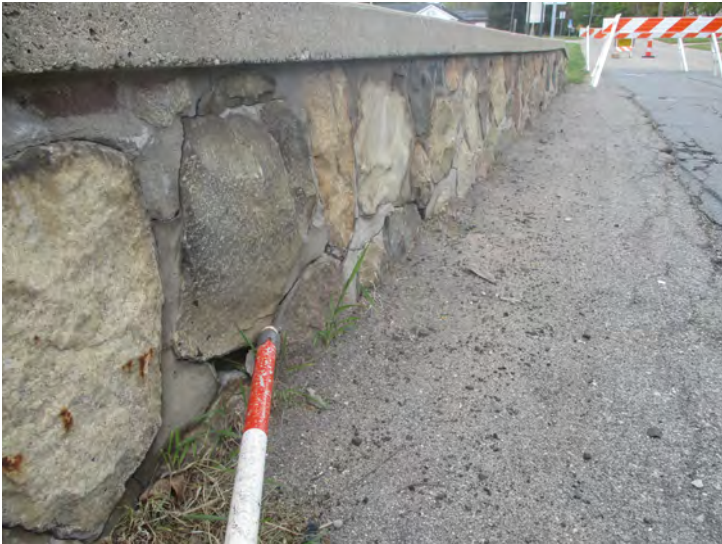
4. Railings	7	7	7	Short height railings. Grouted stone headwalls with concrete cap act as railings. Shallow spall (<1 Sft) in SW as result of vehicular impact. Shallow spall in NW, top of wall. Open (1/16") cracks in mortar, more prevalent in the SE, both sides. (05/21) 2"x4"x14" spall W end S rail top. A few scattered short 1/16" cracks in mortar. A couple shallow spalls on top of rail. NE & SW approach rail moderate corrosion and not attached to bridge. (09/19) A few scattered short 1/16" cracks in mortar. A couple shallow spalls on top of rail. NE & SW approach rail moderate corrosion and not attached to bridge. (11/17)

Document Name: 14.JPG
 Category: Railing
 Span Number:
 Comments: South, open cracks in mortar starting in SW

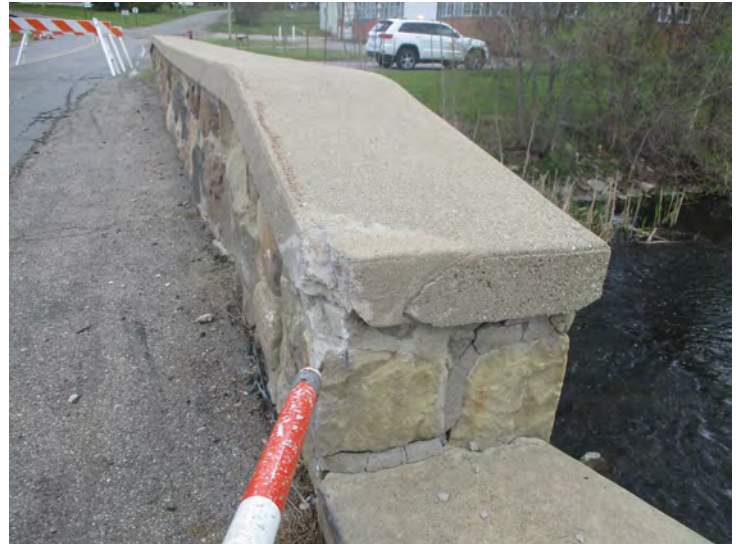
Document Name: 15.JPG
 Category: Railing
 Span Number:
 Comments: South, impact damage in SW

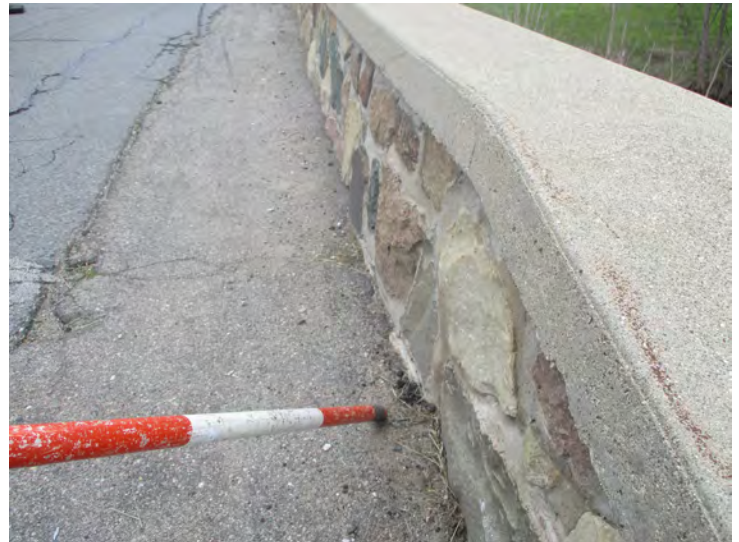
Document Name: 17.JPG
 Category: Railing
 Span Number:
 Comments: South, no separation of railing at impact location.

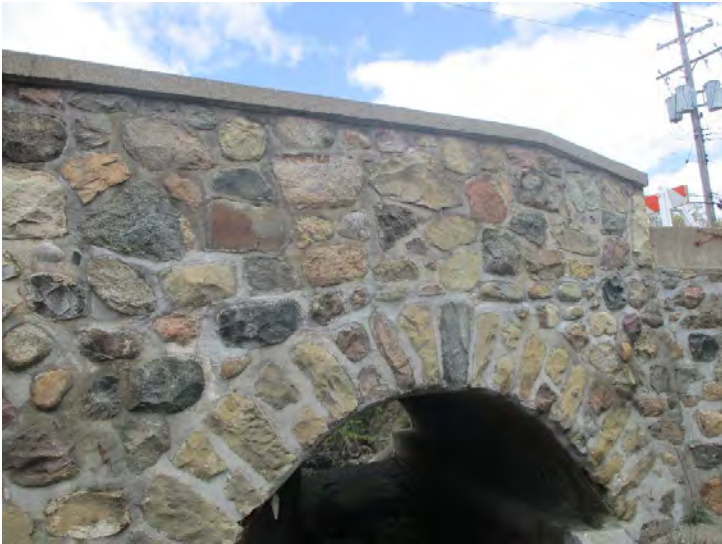
Document Name: 21.JPG
 Category: Railing
 Span Number:
 Comments: South, open crack in mortar in SE

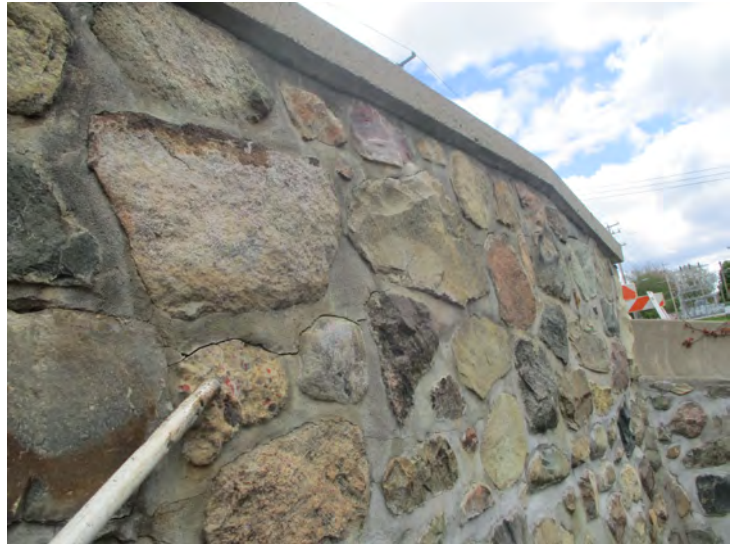
Document Name: 22.JPG
 Category: Railing
 Span Number:
 Comments: South, open crack in mortar in SE

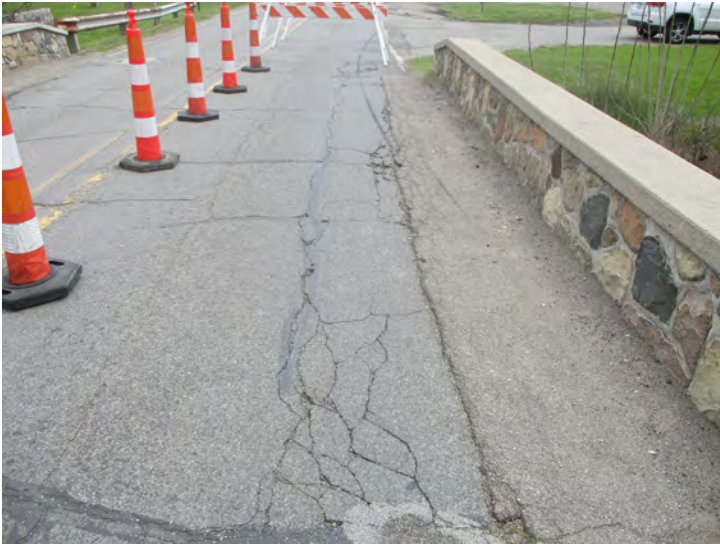
11/17	09/19	05/21	
1. Surface (SIA-58A)	5	5	5	HMA surface. Partially sealed block cracks up to 1/4" wide throughout surface. Open map cracking and 1/4" longitudinal cracks along eastbound lane. Other isolated open transverse, longitudinal, diagonal cracking. Tire rutting. (05/21) Large block 1/16" to 1/4" cracking entire surface with shallow rut along centerline - somewhat undulating. (09/19) Large block 1/16" to 1/4" cracking entire surface with shallow spalls along centerline. (11/17)

Document Name: 10.JPG
 Category: Deck
 Span Number:
 Comments: Deck surface, eastbound lane, open cracks

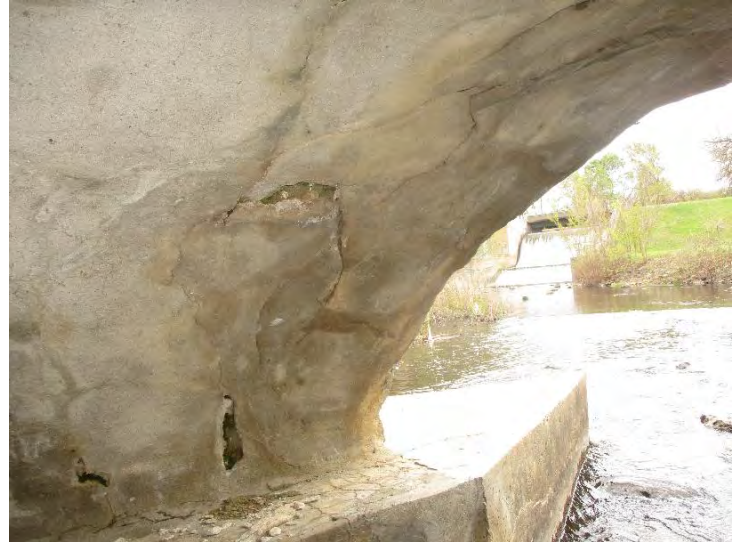
9. Stringer (SIA-59)	5	5	5	3 span concrete stone arch. Walls and soffit previously patched. Span 1w: south end, shallow spalls with open cracks in soffit/walls with leaking stains; 1/8" vertical cracks in west wall/footing. Span 2w: north end, spalls with open cracks in soffit/walls with leaking stains; south end, open cracks with staining in soffit/walls; 1/16" vertical cracks in footings. Span 3w: 6"-8" deep spall (4'x3') with loose fill exposed along south end, west soffit/wall, previous patch material located in bottom of channel; 1/16" vertical cracks in footings; open 1/8" horizontal crack in bottom of east wall, south end, at footing interface. (05/21) Downstream both sides middle arch: 6" x 4" hole and additional spalls in linings. Spandrel walls good - a few scattered hairline to 1/8" cracks in grout, esp. inside near road surface. (09/19) Interior arch lining repair areas OK but many hairline to 1/16" cracks with rust staining. Numerous hairline to 1/8" cracks beyond repaired areas. (11/17)

Document Name: 28.JPG
 Category: Superstructure
 Span Number:
 Comments: Span 1w, soffit, SE corner, incipient/spalling with open cracks

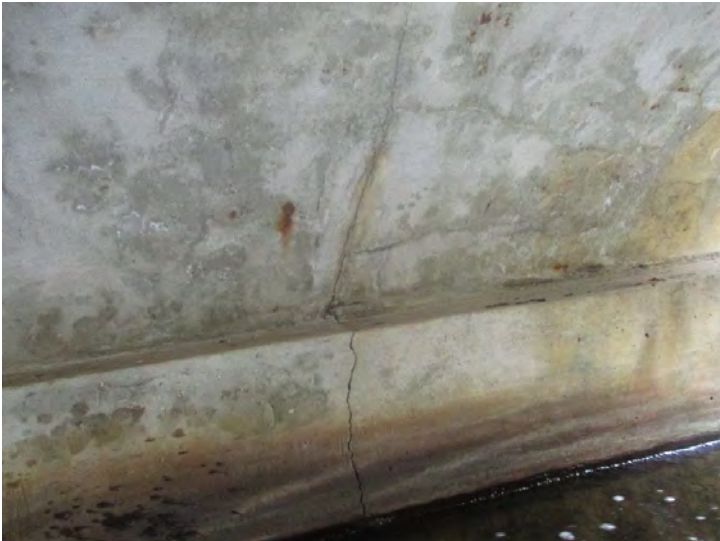
13. Abutments (SIA-60)	6	6	6	Abutments previously patched. Span 1w: south end, shallow spalls with open cracks in walls with leaking stains; 1/8" vertical cracks in west wall/footing. Span 3w: 1/16" vertical cracks in footings; open 1/8" horizontal crack in bottom of east wall, south end, at footing interface. (05/21) Shallow spalling SW corner footing + numerous hairline cracks. Split in NW wing top at 2/3 pt. Footings exhibit hairline to 1/16" vertical cracks with efflorescence at approx. 4' spacing. (09/19) NW wingwall mortar repaired. Footings exhibit hairline to 1/16" vertical cracks with efflorescence at approx. 4' spacing. (11/17)

Document Name: 29.JPG
 Category: Superstructure
 Span Number:
 Comments: Span 1w, west abut, 1/8" open crack in wall/footing

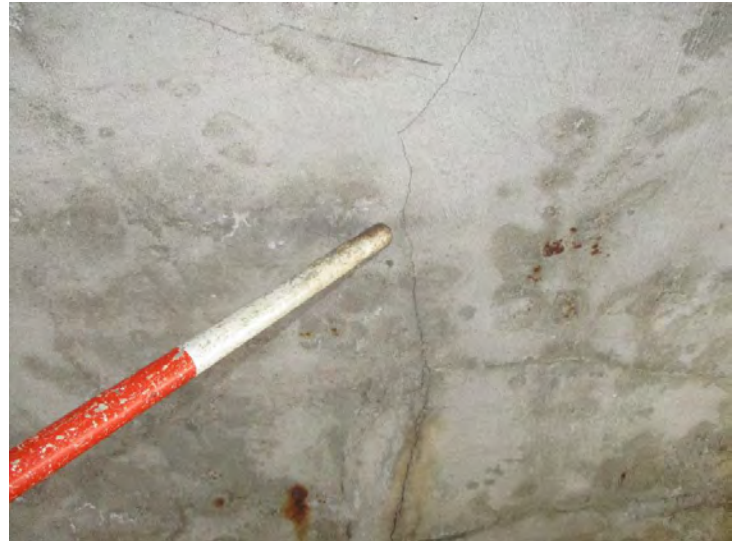
Document Name: 30.JPG
 Category: Superstructure
 Span Number:
 Comments: Typical cracking in arch

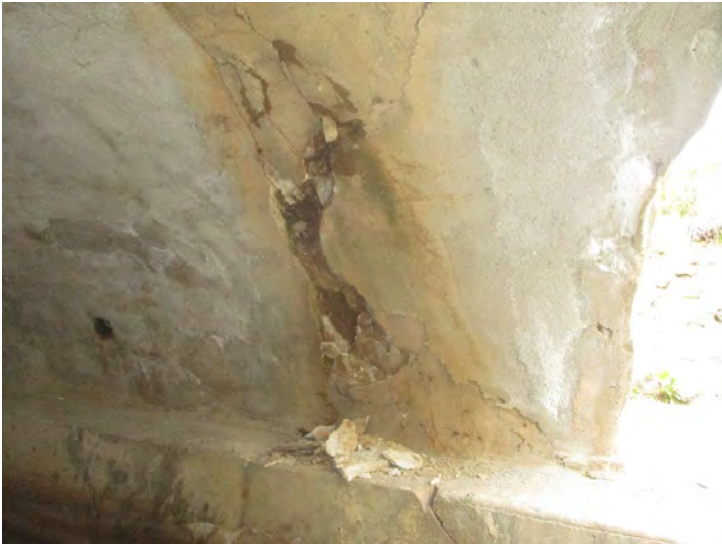
14. Piers (SIA-60)	5	5	5	Walls previously patched. Span 1w: south end, shallow spalls with open cracks in walls with leaking stains. Span 2w: north end, spalls with open cracks in walls with leaking stains; south end, open cracks with staining in walls; 1/16" vertical cracks in footings. Span 3w: 6"-8" deep spall (4'x3') with loose fill exposed along south end, west wall, previous patch material located in bottom of channel; 1/16" vertical cracks in footings. (05/21) Footings exhibit small vertical cracks at approx. 4' spacing. Shallow spall and many hairline cracks E face of W pier under downstream end of barrel. (09/19) Footings exhibit small vertical cracks at approx. 4' spacing. Moderate to heavy conc delamination and spalling at east downstream footing face. (11/17)

Document Name: 32.JPG
 Category: Superstructure
 Span Number:
 Comments: Span 2w, pier 1w, north end, east face, open spalls/cracking

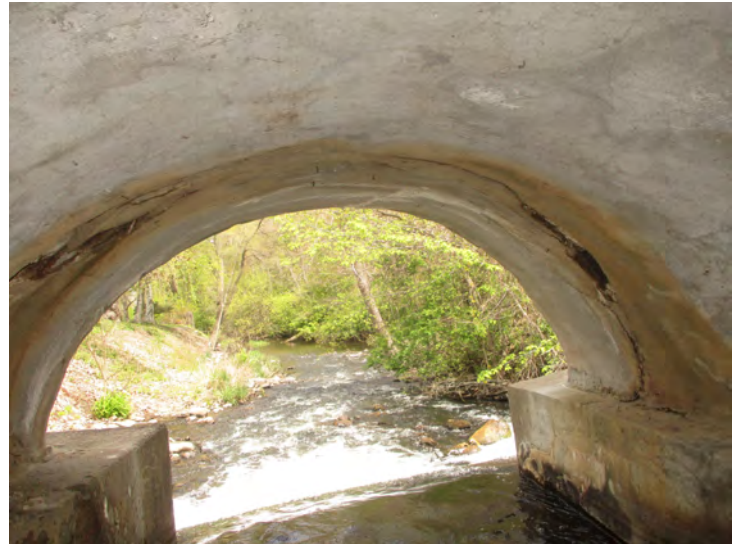
Document Name: 33.JPG
 Category: Superstructure
 Span Number:
 Comments: Span 2w, pier 1w, north end, open spalls/cracking

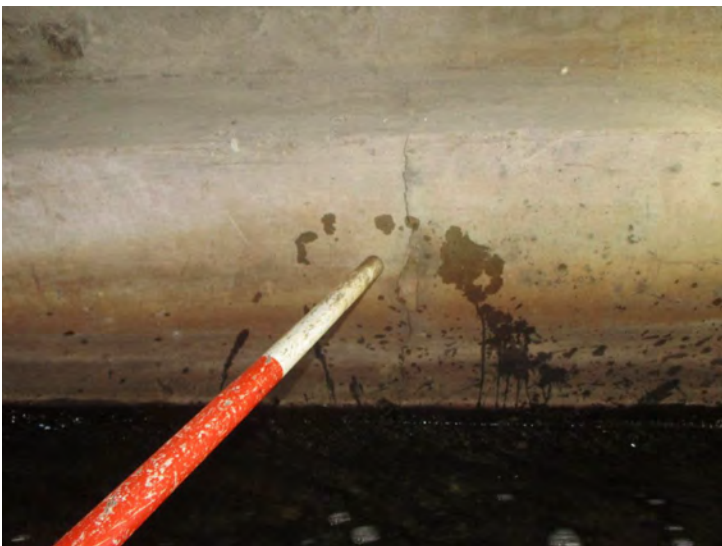
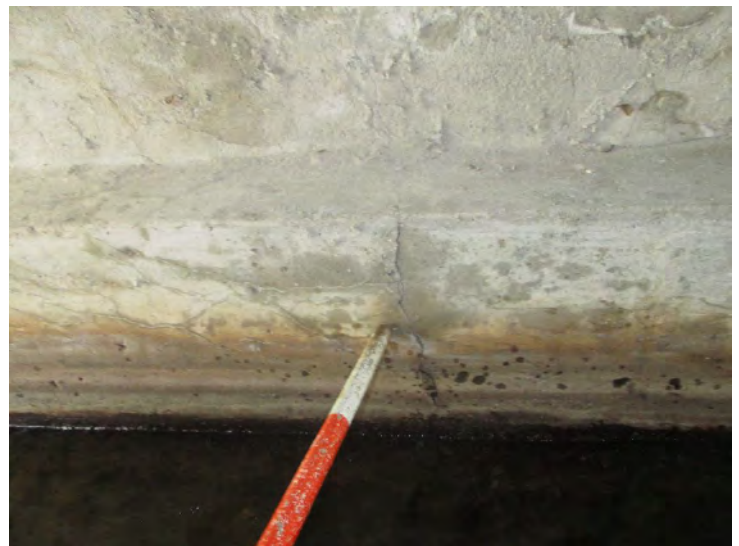
Document Name: 34.JPG
 Category: Superstructure
 Span Number:
 Comments: Span 2w, typical 1/16" cracks in wall

Document Name: 35.JPG
 Category: Superstructure
 Span Number:
 Comments: Span 2w, typical 1/16" cracks in wall

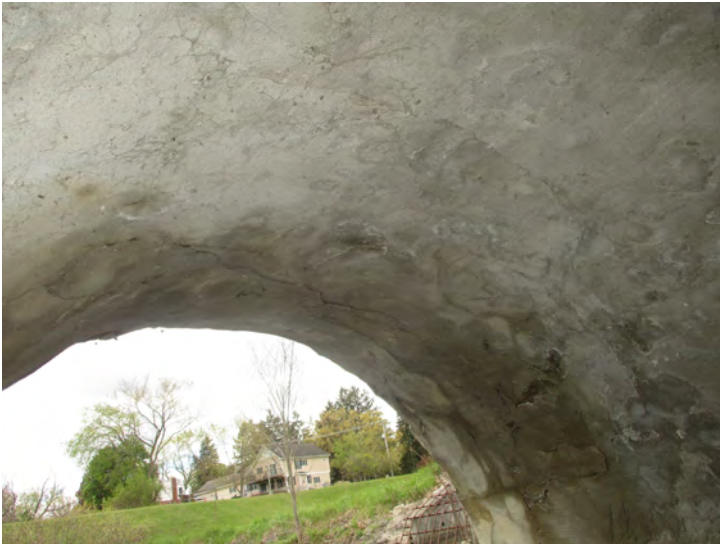
Document Name: 41.JPG
 Category: Superstructure
 Span Number:
 Comments: Span 2w, soffit, south end, open cracks

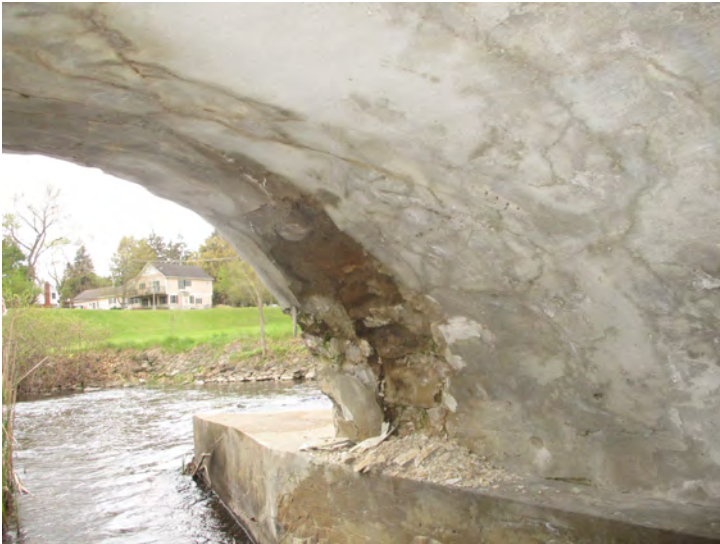
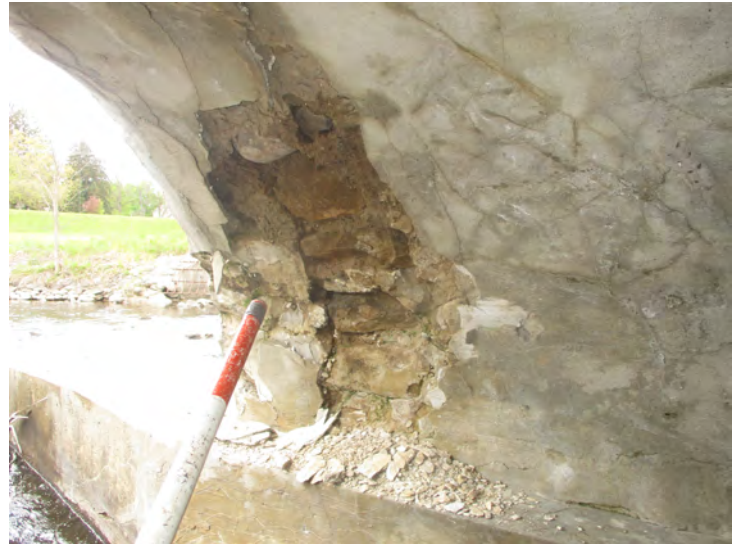
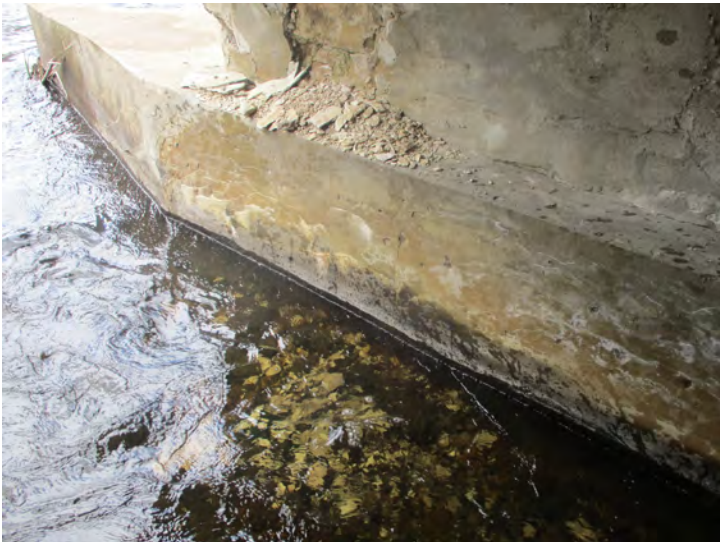
Document Name: 46.JPG
 Category: Superstructure
 Span Number:
 Comments: Span 3w, pier 2w, south end, spall in soffit

Document Name: 47.JPG
 Category: Superstructure
 Span Number:
 Comments: Span 3w, pier 2w, south end, spall in soffit

Document Name: 48.JPG
 Category: Superstructure
 Span Number:
 Comments: Span 3w, pier 2w, south end, spall in soffit

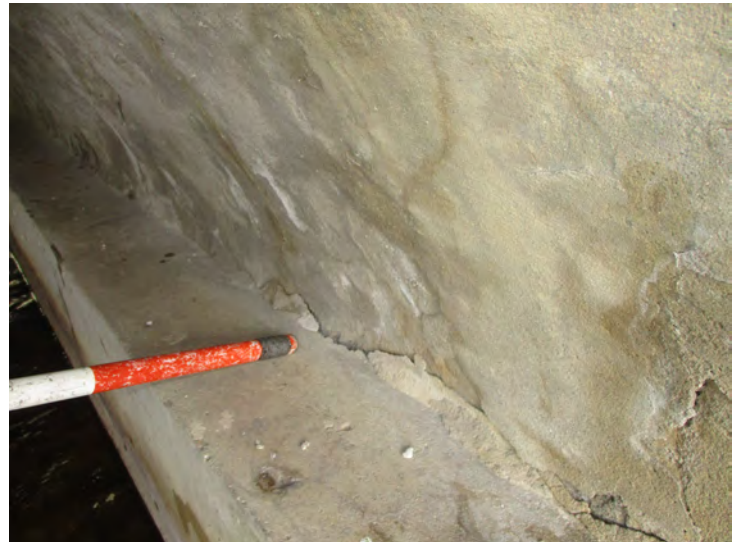
Document Name: 50.JPG
 Category: Superstructure
 Span Number:
 Comments: Span 3w, east abut, south end, 1/8" open crack
